That’s Gonna Leave a Mark

By AM1(AW) Steven Kedzie

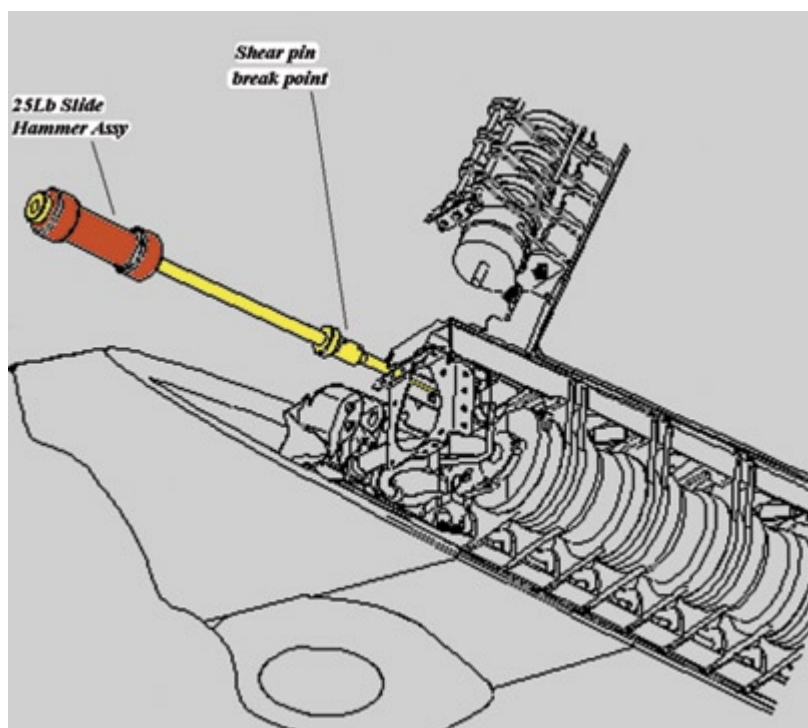
The slide hammer looks exactly as its name implies. It is a sliding handle with stops on either end, and it’s threaded to one end of an extension shaft (see picture). The other end of the extension shaft is threaded to the wing pin being installed or removed. By moving the slide hammer back and forth to the desired stop, the wing pin is driven in or out of its housing. A shear pin resides in the threaded connection between the slide hammer and the extension shaft. The purpose of the shear pin is to

prevent damage to the wing pin by breaking and releasing the slide hammer from the shaft if too much force is imparted on it during hammering.

After the initial step of removing the various panels and hardware from the wing, large wing pins must be removed before the outer wing is free of the wing-fold transmission. Each of these pins is approximately one meter long and made of solid titanium. Their removal requires the use of a common tool: the slide hammer.
